**Date:** *TODAYS DATE*      **BA #:** *0001*

**Bright Carbon Steel with "STD" Bevel  
Doctor Blade**

#### **SAMPLE BLADE AUDIT:**

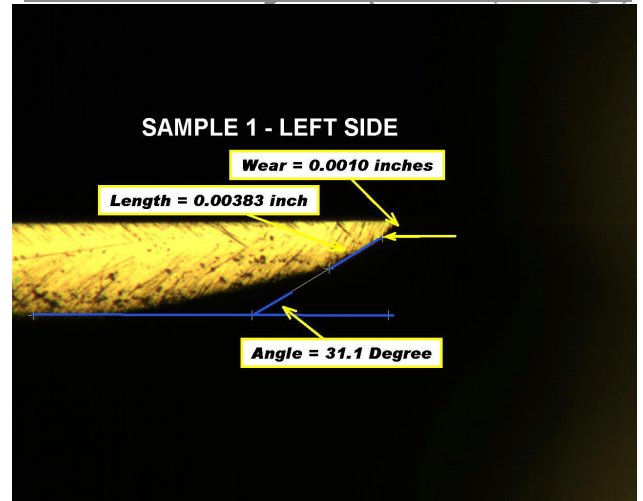
Left Side Facing Roll (Microscope Image)

This blade was installed incorrectly with the machined bevel against the roll.

This is very likely to be a significant source of the coating defects observed, as some 'semi-dried' coating is very likely to get trapped under the big initial 'footprint' of the beveled surface, which is designed/intended to be away from the roll. Additionally, the contact angles worn in are too flat. (See general comments.) This will greatly increase the 'trapping' and blade-tip-lifting phenomena. There is some evidence of 'bowing' of the blade holder/system since the center contact angle is nearly 10 degrees greater than those on either end.
